A restorative dilemma?

Tom Bereznicki and Lucy Clements present the restoration of deep interproximal boxes in class II cavities using the 'sandwich' technique

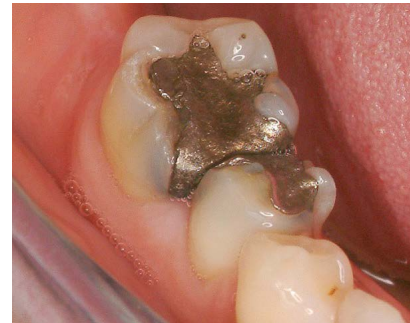
Figure 1a: Conventional 30-year-old amalgam restoration

Figure 1a shows a typical lathe cut conventional amalgam placed 30 years previously – note that despite surface corrosion and minor marginal breakdown this could still be regarded as clinically successful. In the 1960s, amalgam improved dramatically as a dental material following the development of spherical particle alloys and an altered chemistry (by the addition of copper to reduce the weak Gamma 2 phase) resulting in a stronger and more corrosion-resistant alloy (Bharti

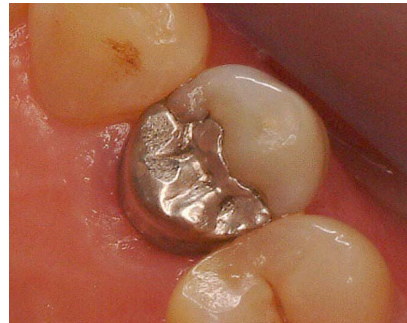
Figure 1b: A typical high copper amalgam after 25 years' service

Despite the lack of any adhesive properties, in the presence of good oral hygiene, General Dental Practitioners (GDPs) found recurrent caries to be rare (Lai et al, 2013), and the increased strength of the alloy to allow large cusp replacement restorations to be predictably placed (Wahl, 2003). Figure 1b shows a typical high copper amalgam after 25 years' service. Further improvements to longevity came with the development of 'amalgam bonding' (Setcos et al, 1999) although there is little clinical data indicating the effectiveness of this technique.

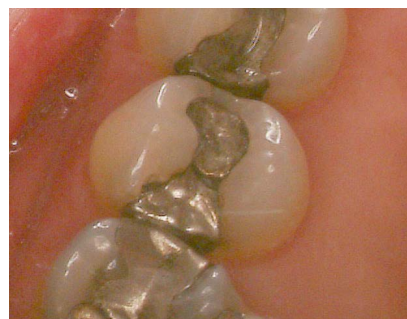
Figure 2: Restoration suffering a rapid loss of marginal integrity and rampant caries

Following initial work by Buonocore in 1954, composite resins slowly started to replace silicate restorations in anterior teeth. With the development of auto-curing macrofilled composites for class III restorations, it only became a matter of time before their use spread to class II restorations. These materials were difficult to polish, with the poor bond of the filler particles to the resin rapidly leading to particle and matrix loss which in turn resulted in surface roughening and accelerated wear of the opposing teeth (Coombe and Burke, 2000). In addition, initial bonding strengths to enamel were poor and non-existent to dentine, resulting in these restorations suffering a rapid loss of marginal integrity and rampant caries as shown in Figure 2 (Pashley, 2003).

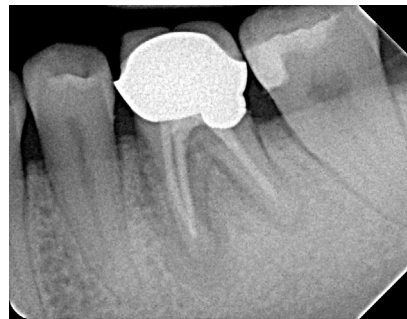
Figure 4a: September 2004 - Left LCPSA showing intact mesio occlusal restoration on lower left second molar (LL7) after placement in March 2003

Meanwhile, research was confirming clinical findings that the expected median longevity of composite restorations was four years (Chrysanthakopoulos, 2012). Much of this has been attributed to the breakdown of the bond of composite to dentine which starts to degrade as early as six months post placement (Breschi et al, 2008). Figures 4 a to d show the all too typical sudden appearance of caries once the bond to dentine suffers total failure – in this case six and a half years.

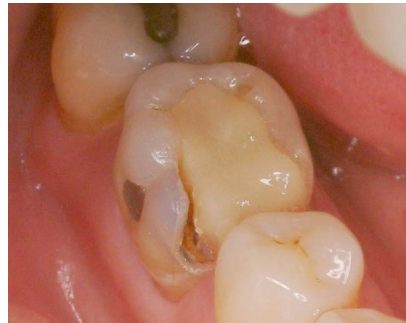
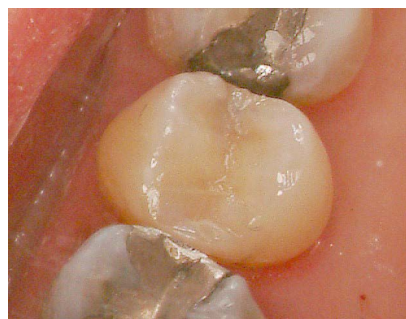
Figure 3a-3b: The ideal clinical situation if long-term success of the composite is expected – all the margins of the restoration being in enamel

Figures 3a and 3b show the ideal clinical situation if long-term success of the composite is expected – all the margins of

the restoration being in enamel.

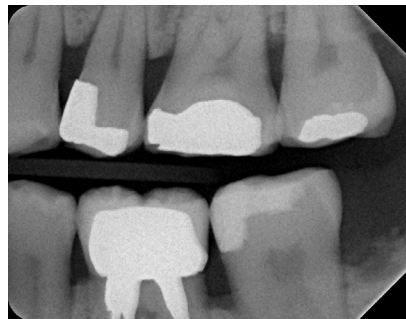
Figure 4b: June 2006 - Left bitewing showing intact mesio occlusal restoration in the LL7

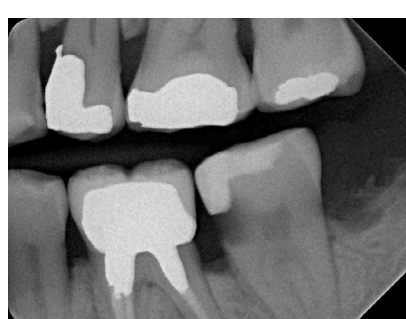
Figure 4d: September 2009 - Left bitewing showing sudden rapid recurrent caries in the LL7 mesially

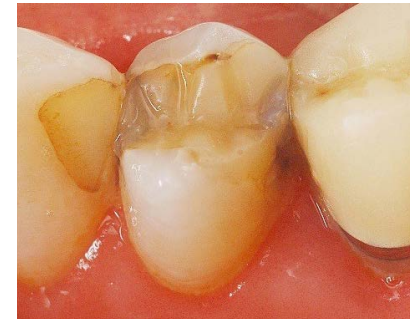
Figure 6: Intra oral photograph of UL4 showing intact composite occlusally despite dissolved GIC in the cervical box beneath

Figure 6 shows a photograph of the same restoration in 2012. The overlying composite placed over the GIC is intact despite the dissolving GIC which had been placed cervically in the box of the class II cavity.

Interestingly, on removal of the restoration there was no secondary caries present in the floor of the box despite the absence of the original GIC.
