# The creation of an emergence profile to improve the aesthetics of a conventional bridge in a high lip line case

Tom Bereznicki & Wayne Holness

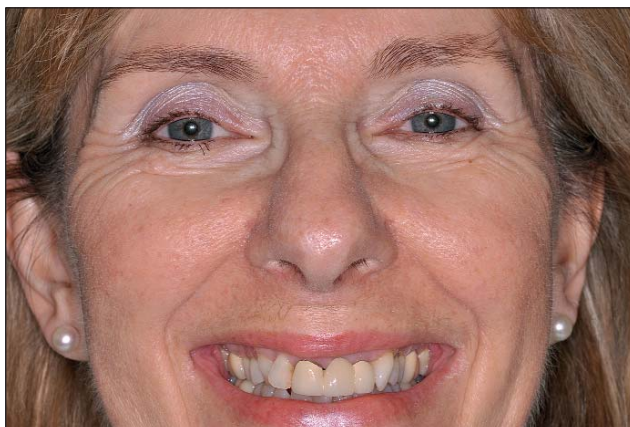
Figure 1: The patient on presentation

The patient shown in *Figure 1* clearly demonstrates a case where these criteria were not met. Poor gingival margins are visible on the abutment teeth, the pontic tooth does not match the height of the contra-lateral central incisor and the overall impression is of artificial teeth. The closer view in *Figure 2* clearly shows the failing bridge, poor aesthetics related to the colour of the porcelain and the lack of normal tooth contours. There is an unsightly open embrasure and lack of papilla between the incisor pontic leading

The patient shown in *Figure 1*, having completed a course of

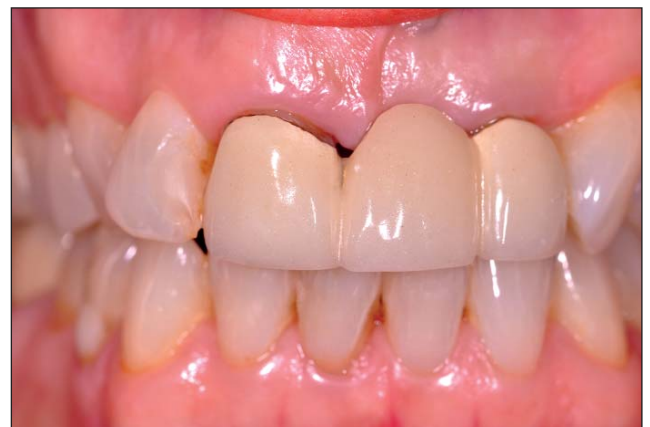
Figure 2: Pre-treatment intraoral view

to an unsightly black 'triangle'. There is also a failing discoloured composite on the mesial surface of the right lateral incisor. Finally, the flabby fraenum and the longstanding fibrosed sinus above the left central further complicate the aesthetics.

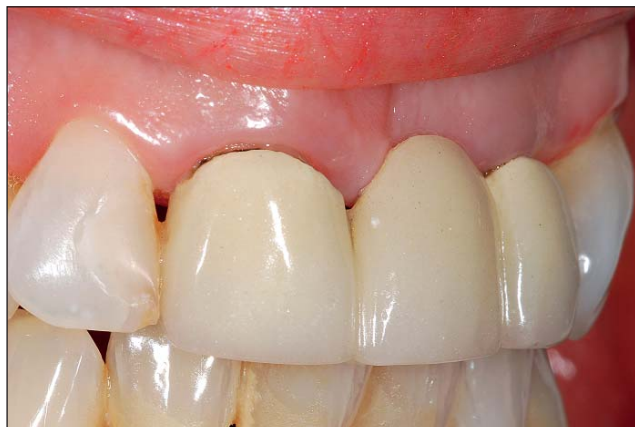
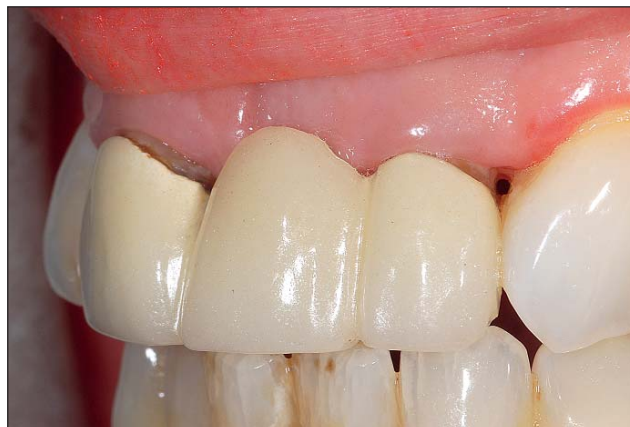
Figures 3-4: Lateral views

The close-up lateral views in *Figures 3 and 4* show recurrent caries as a result of a poorly fitting bridge. The 'ridge-lap' design pontic is 'sitting'

on the underlying gum rather than emerging from within the surrounding gingivae, giving an artificial appearance to the replacement tooth.

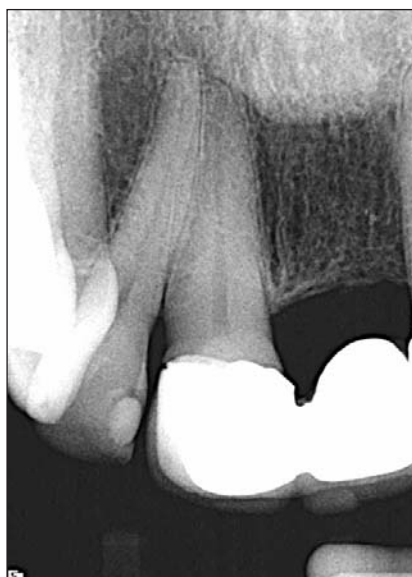
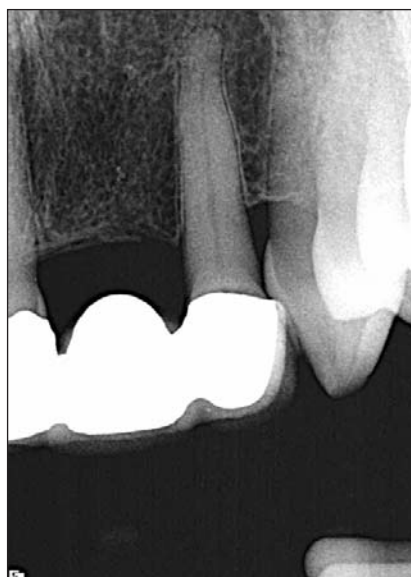
Figures 5-6: The radiographic appearance of the bridge and abutment teeth

In the case being presented, it is clear from the radiographs that there is sufficient soft tissue thickness available between the gingiva and the underlying bone indicating that it would be unlikely for osseous re-contouring to be necessary as part of the surgical procedure. It is important to realise that this tissue thickness should be confirmed at the time of ridge preparation and the technique adapted to include osseous re-contouring if necessary. It was also pointed out to the patient that there was residual fibrous tissue in the buccal mucosa remaining from an old discharging sinus associated with the extracted upper left central as well as a fleshy

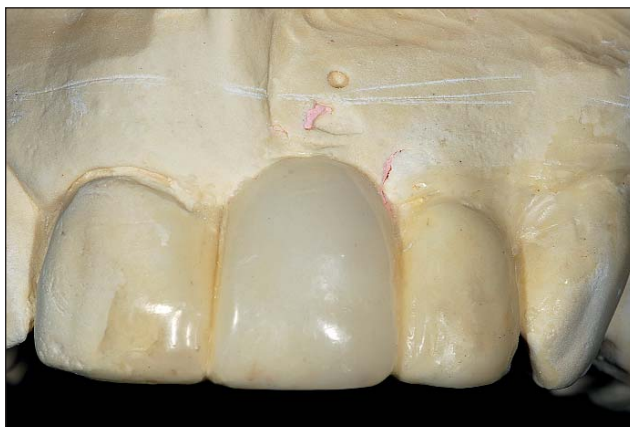
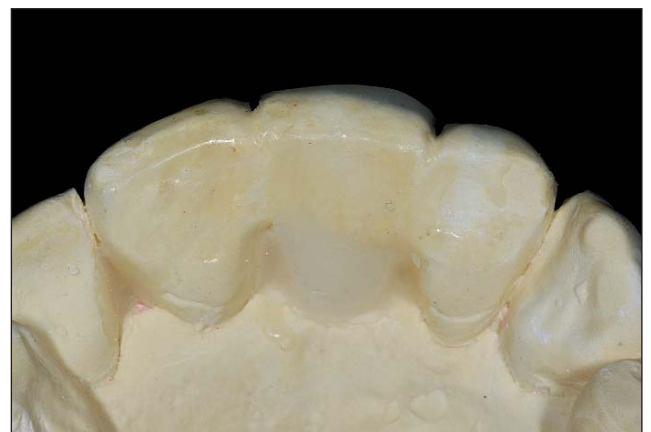
Figure 7a: Labial view of wax up

Alginate impressions (Palgat Plus, ESPE) were taken and poured to give working models. As the case would require the chairside fabrication of a temporary bridge a diagnostic wax-up was carried out on the upper model to re-define the bridge contours and thicken the palatal aspects of the existing pontic to allow the provision of an ovate design at the time of the surgical procedure (*Figure 7a-b*). The authors' preference in cases such as this is for the chairside temporary bridge to be constructed using a rigid suck-down stent (Proforma) as shown in *Figure 7c*.

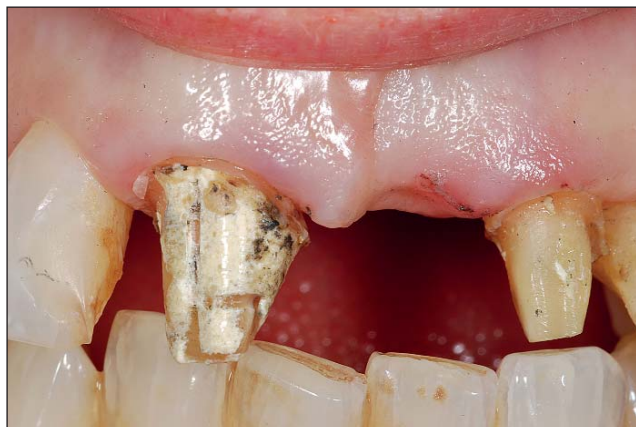
**Figure 8:** Clinical appearance upon removal of the bridge

Local anaesthesia was administered and the existing bridge sectioned and removed. *Figure 8* shows the clinical picture, particularly the low fleshy fraenal attachment which unless removed would compromise the final aesthetic result.

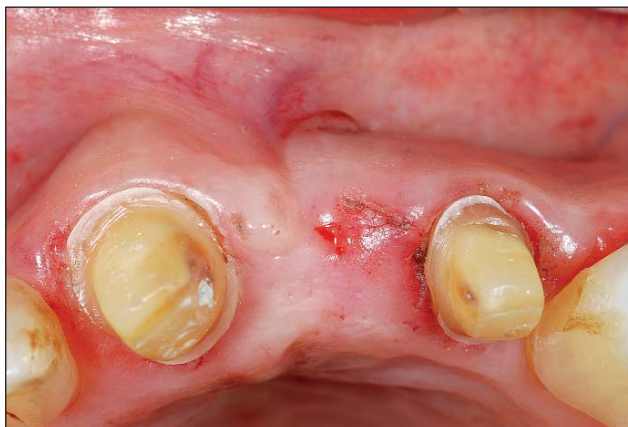
**Figure 9:** The available ridge

*Figure 9* shows the edentulous ridge following minimal re-shaping and caries removal from the abutment teeth. There is some residual sub-lingual calculus on the mesial surface of the lateral incisor which was root-planed. The ridge shows adequate width mesio-distally, ample attached gingivae and the authors' opinion was that neither osseous nor soft tissue grafting was necessary to achieve the desired aesthetic result.

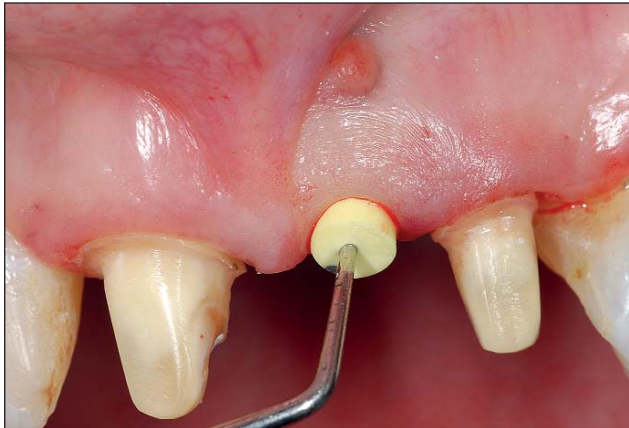
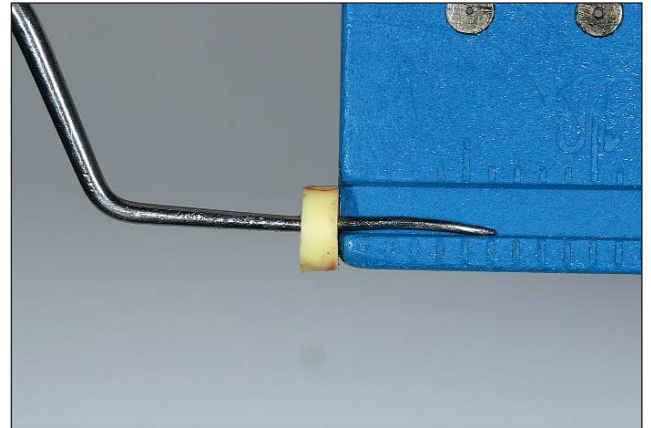
Figure 10: a-b – Bone sounding and measurement of the available gingival thickness

As mentioned previously, although there appeared to be an adequate thickness of gingival tissue in the edentulous area, it was decided to carry out bone sounding to confirm the radiographic evaluation. The authors prefer the use of a slightly blunt probe for the procedure to avoid accidental penetration of the underlying bone which would distort the true thickness measured. *Figure 10a* shows the bone sounding clinically and depth measurement with a rubber stop. The available gingival thickness measured 6mm (*Figure 10b*).

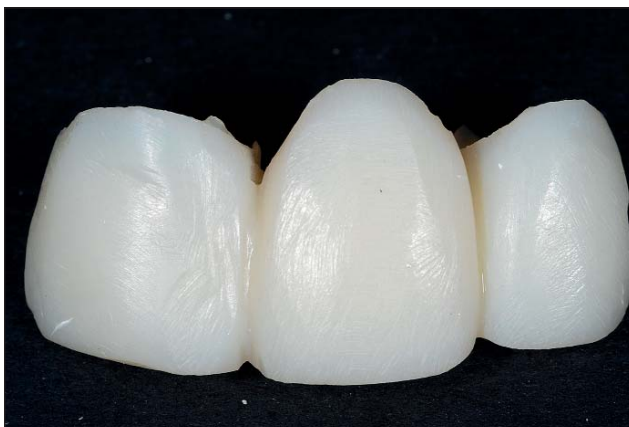
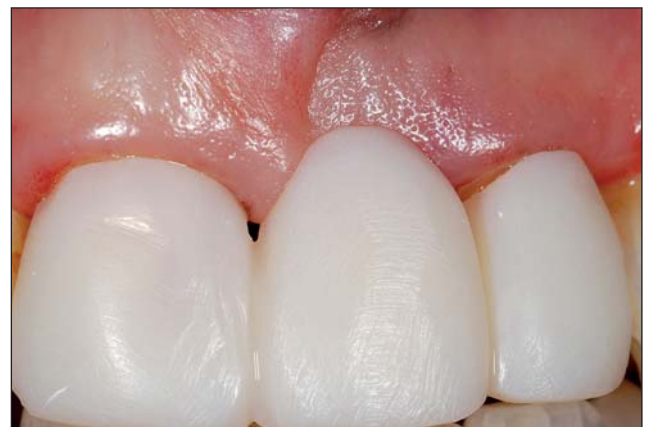
Figure 11: a-b – The temporary bridge after trimming and polishing and trial fitted

filled with a temporary crown and bridge material, Protemp Shade A2 (3M ESPE), and fitted in the mouth until fully set. The bridge is shown after trimming and polishing (Figure 11a) and trial fitted in the mouth (Figure 11b). It is clear that the bridge is an improved copy of the original in that it still shows open embrasures and a ridge-lap pontic design.

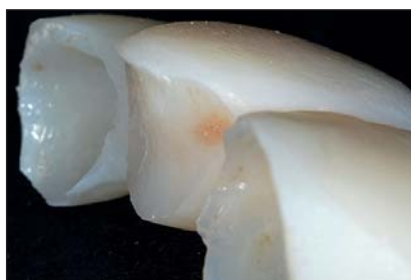
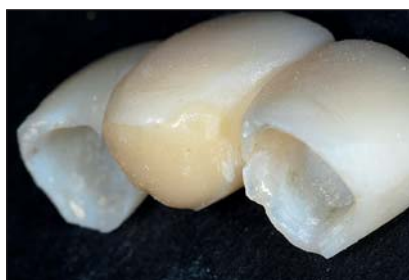
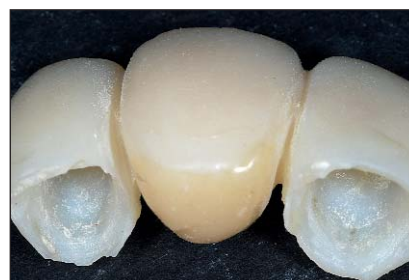
Figure 12: a-c – Conversion from ridge lap to ovate pontic

The next step was to convert the ridge-lap pontic (Figure 12a) to an ovate design. This is achieved by applying composite activator to the fit surface of the pontic, air drying after 20 seconds and applying All

Bond (Bisco) and light curing for 20 seconds. Venus Shade A3 (Heraeus Kulzer) composite is moulded to the prepared area to increase the height of the pontic by 3mm (the 6mm of gingival thickness present minus the desired 3mm necessary to maintain the biologic width discussed previously) and to reshape it to an ovate design. Once the correct form is achieved it is light cured for 40 seconds. The surface is then trimmed with discs (Soflex – 3M ESPE) and polished with rubber wheels (Shofu) and impregnated brushes (Occlubrush – Kerr). The completed pontic is shown in

Figures 12b-c. The darker shade is used to allow differentiation between the original bridge and the new additions.

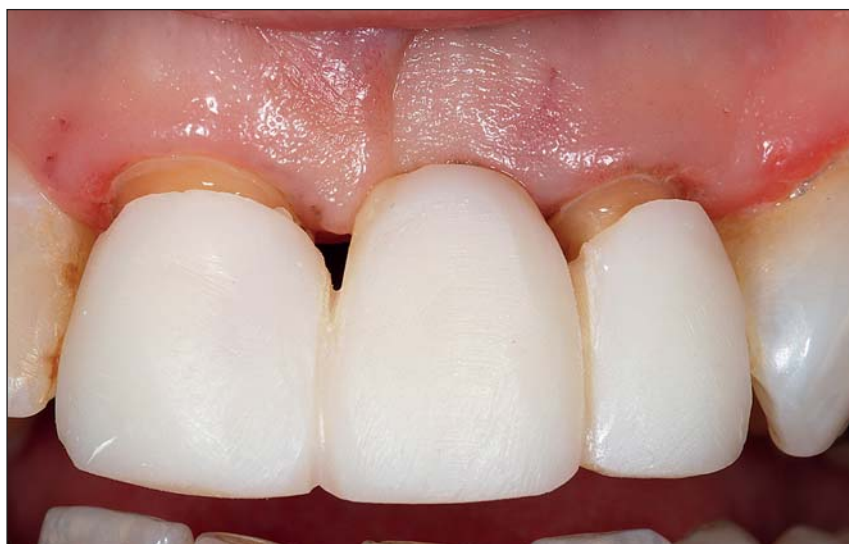
Figure 13: The modified bridge on re-fitting

On refitting the bridge in the mouth, the bulk of composite added during the conversion to an ovate pontic does not allow full seating (Figure 13). The gap between the bridge margin and the margins of the preparations should not measure more than the desired 3mm. If the height measured is greater, then the fit surface of the pontic has to be reduced until the correct dimensions are achieved.

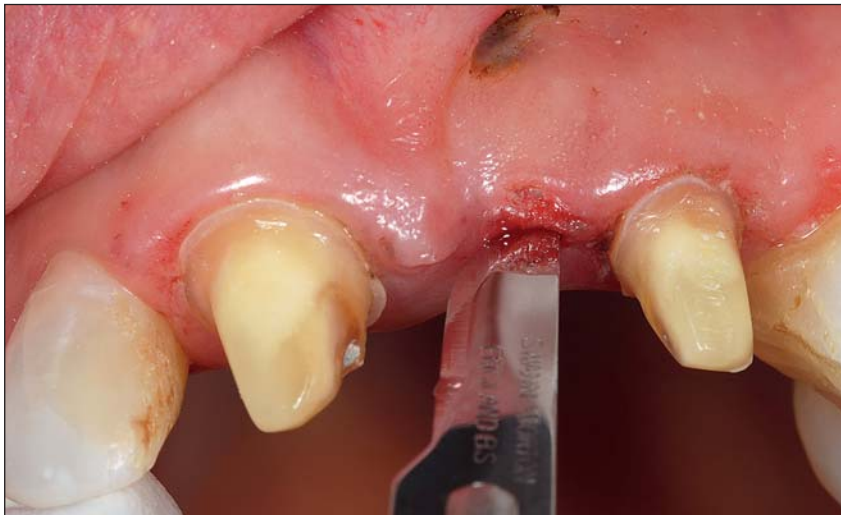
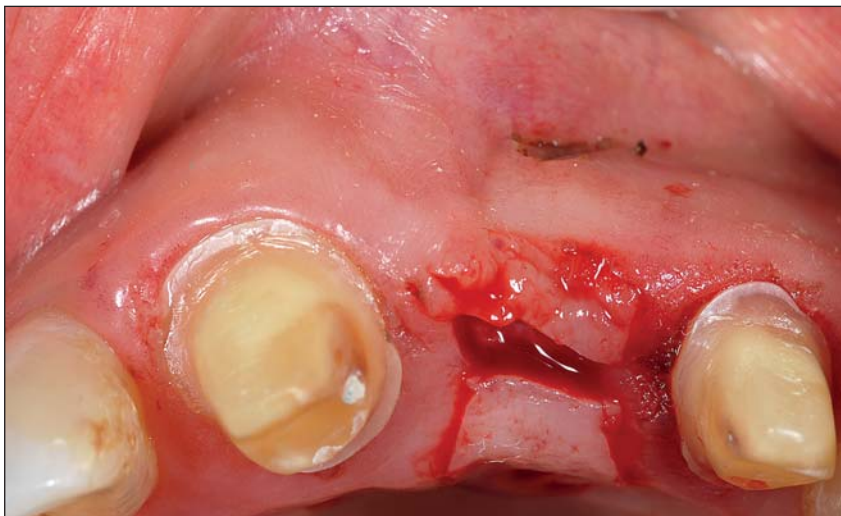
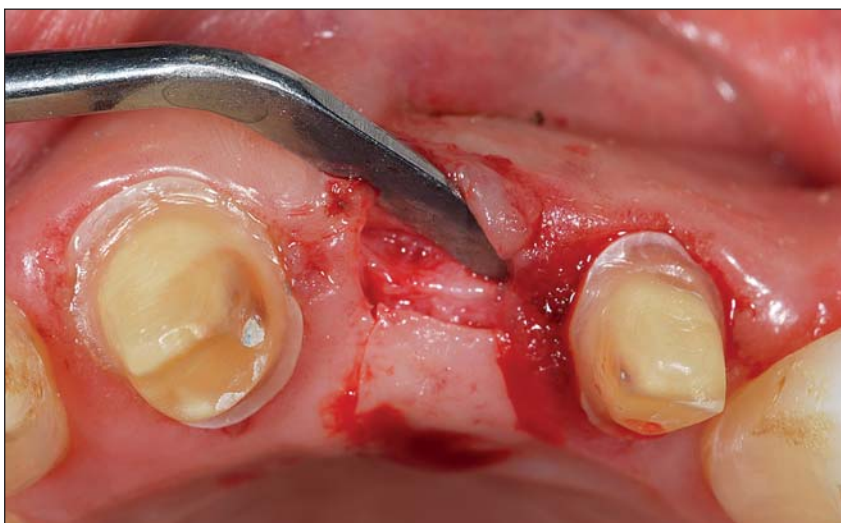
Figure 14: a-c – The surgical steps

With the bridge correctly prepared the minor surgical procedure can now be undertaken. The authors prefer to make the incision to the bony crest, using a No 15 scalpel blade, to be placed palatal to the midline of the ridge (*Figure 14a*) with relieving incisions both mesially and distally avoiding the existing the papillae (*Figure 14b*). Minimal labial and palatal flaps are then raised by gentle pressure with a thin periosteal elevator (*Figure 14c*).

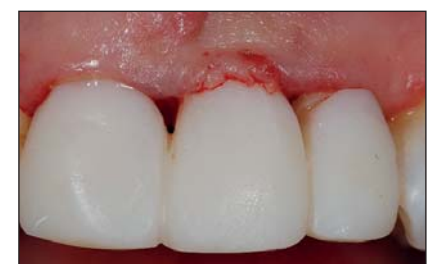
Figure 15: The temporary bridge fully seated

the bridge should be achieved. At this point, the distance between the pontic and the underlying bone should be checked from the palatal aspect to ensure that the desired 3mm space is present. If the gap present is less than 3mm the bridge should be removed and adjusted accordingly until the correct space is created (*Figure 15*).

To maintain the excellent aesthetics of the bridge, it is cemented with TempBond Clear (Kerr) rather than the whiter normal temporary cements, such as original TempBond (Kerr) which have a tendency to show through the thinner sections of

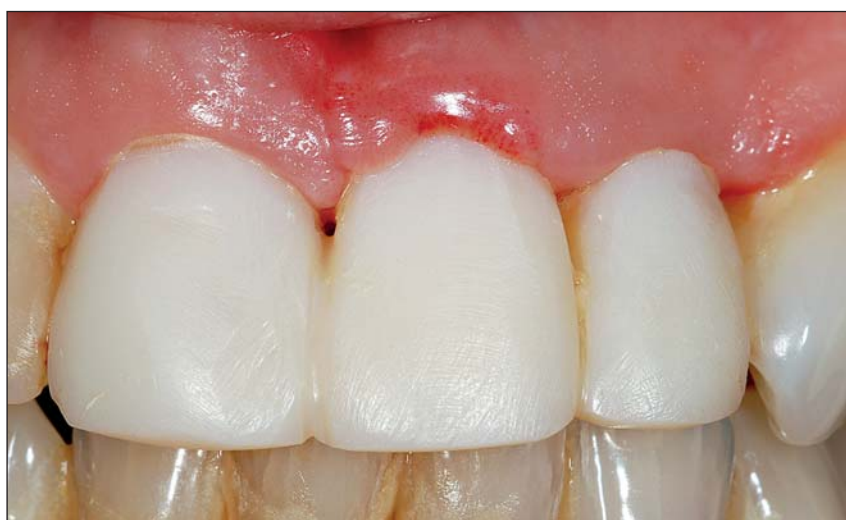
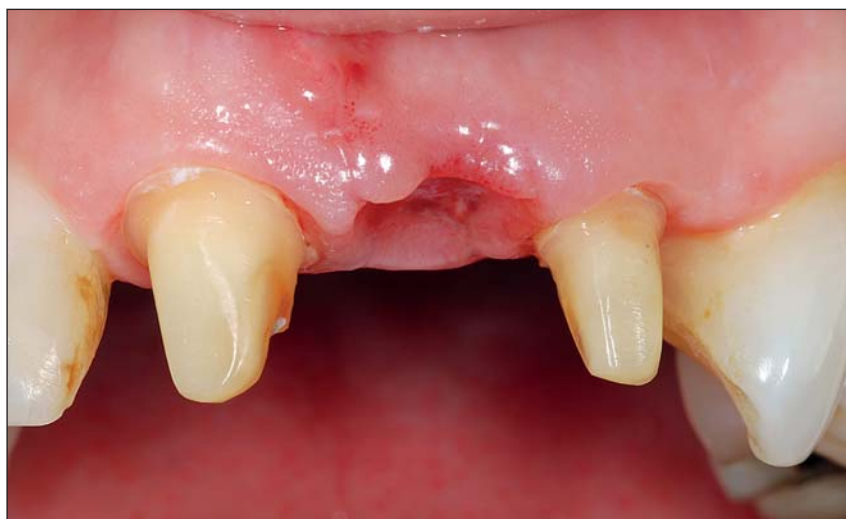
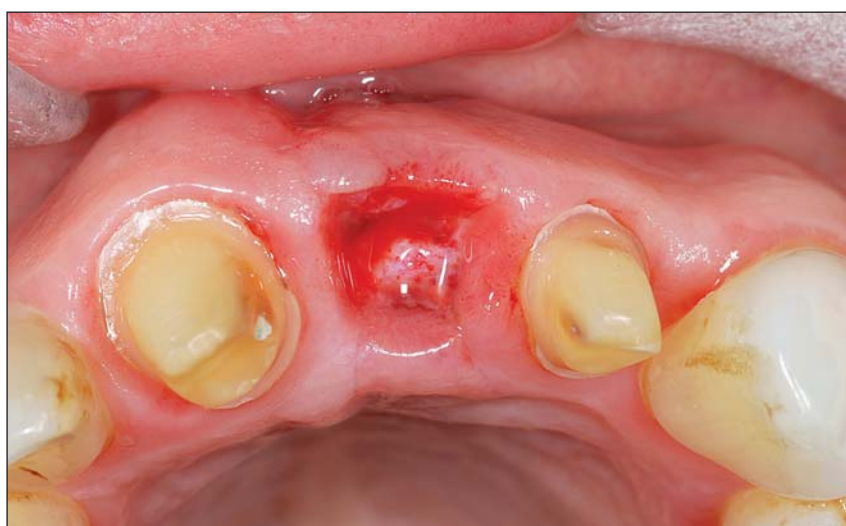
Figure 16: a-c – The tissues at 1 week review

On review the patient reported only mild post-operative discomfort and no swelling after the procedure. The rapid healing is self-evident (*Figures 16a-c*). At this point, as the embrasures were still wide open showing black 'triangles' both mesially and distally, the design and shape of the pontic was altered with the further addition of composite mesially and distally at subgingival level in order to apply pressure in the interdental area. This pressure compresses the papillae and stimulates them to fill the space available interdentally on the bridge. The use of Corsodyl Mouthwash was extended for a further week.

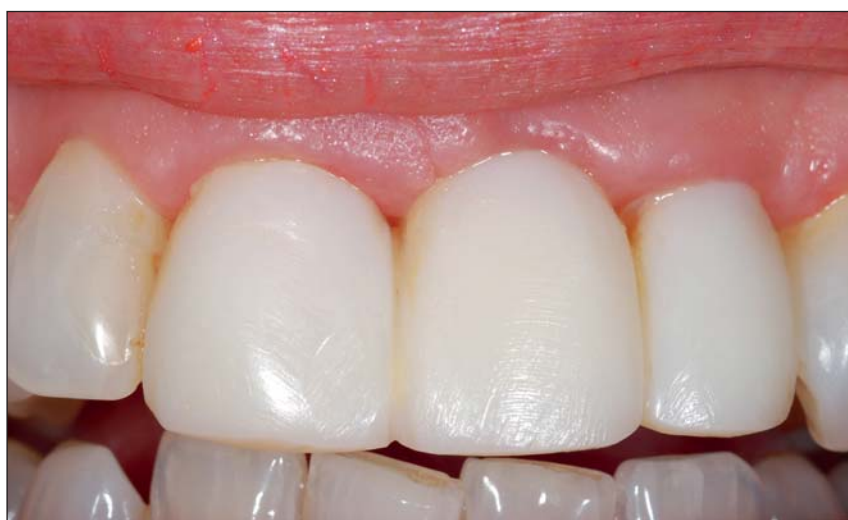
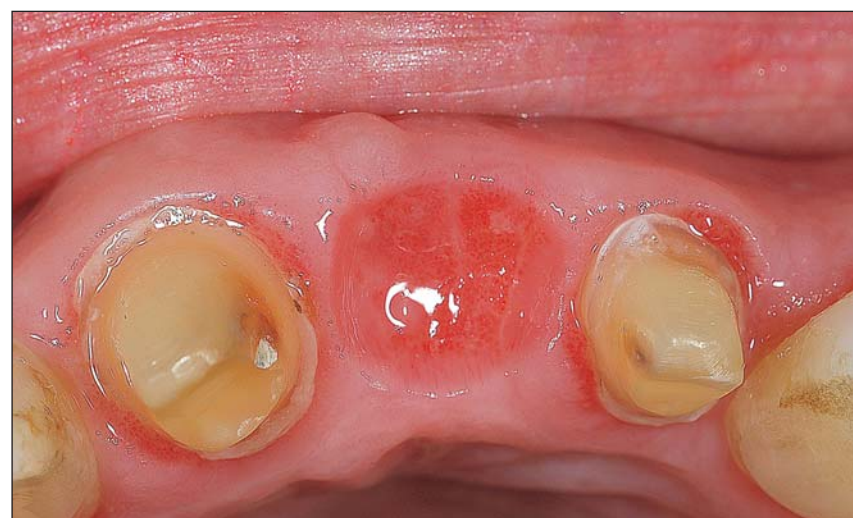
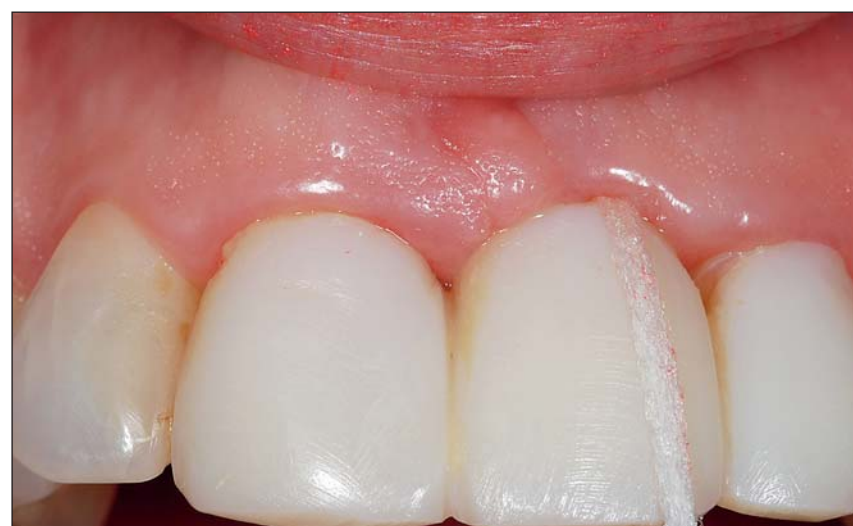
Figure 18: a-c – 10 week recall

The case is shown at 10-week review. The papillae have started to infill the embrasures created and have better contours. The gingiva in the pontic area has matured further (*Figures 18a-b*). To encourage further tissue maturation in the pontic area, the patient was shown the use of Super Floss (Oral-B). The ovate pontic design allows easy passage of the Super Floss between the pontic and the underlying gingivae (*Figure 18c*). The patient was encouraged to try to keep some finger pressure on the incisal tip of the bridge so as to avoid accidental dislodgement.

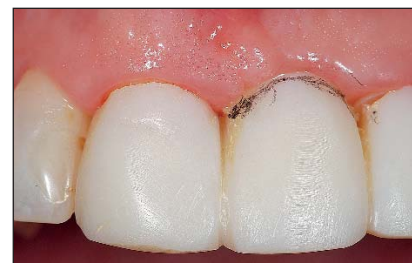
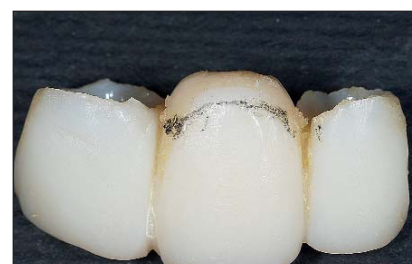
Figure 19: a-c – Pencil line to define area for reduction

At this recall appointment it was also considered that the gingival tissue above the pontic was too high in comparison the adjacent central incisor. In the same way that the shape and height of the papillae can be influenced by adding or reducing the width of composite in the interdental area, so too can the height of the gingivae buccally. If the height of the gingiva is to be raised composite should be added buccally, if lowered then the thickness should be reduced. A useful tip is drawing a pencil line at the gingival margin with the bridge in place. Additions or reductions should only take place above this line. In this case the buccal thickness that is situated under the gingival tissue was reduced and blended to avoid altering the existing interdental contours.

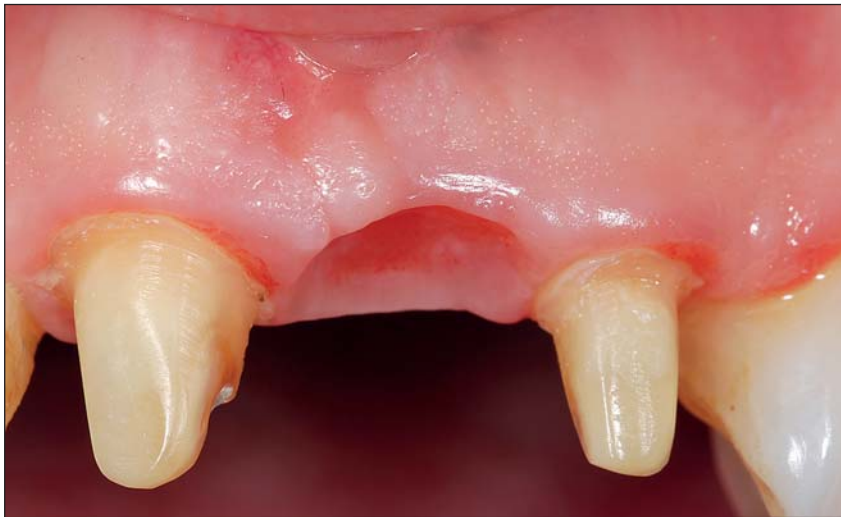
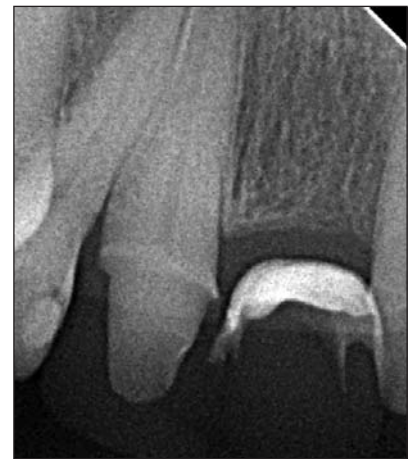
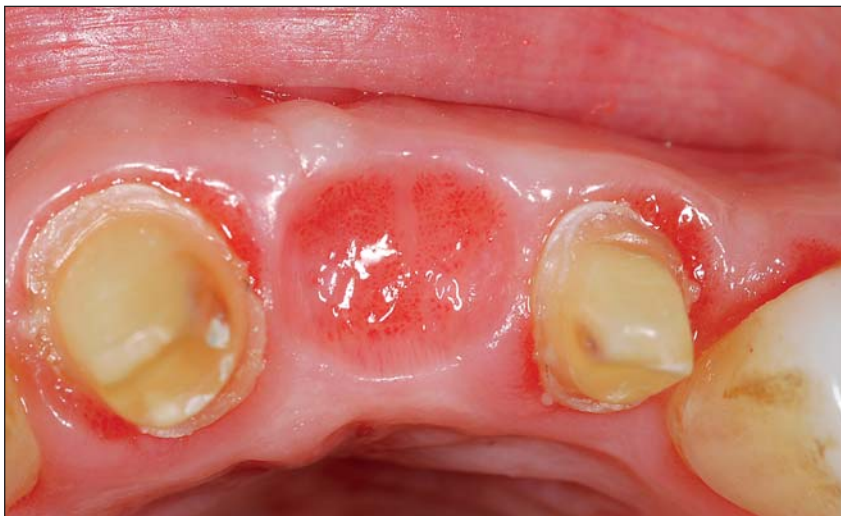
Figure 20: a-c – 13 week recall

The tissues at 13 week recall show excellent maturity (*Figure 20a*). The inability to completely eliminate some superficial inflammation in the pontic area (*Figure 20b*) is related to the inability to leave the fit surface of the pontic area completely porosity free. A check radiograph can be taken to confirm that adequate space exists between the pontic and the underlying bone and that the biologic width has not been encroached upon (*Figure 20c*). It was felt that the emergence profile could not be improved further and appointments were made for the final impressions to be taken.

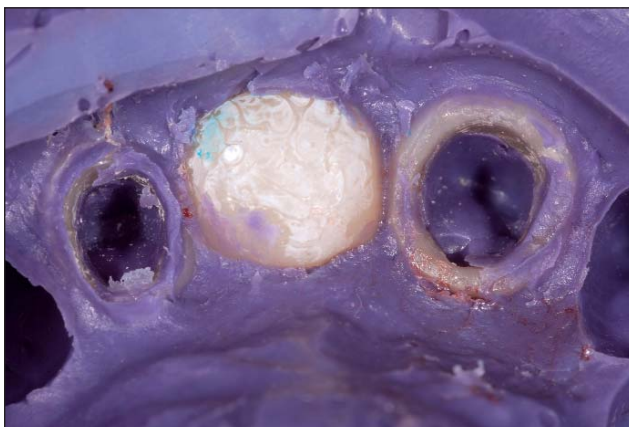
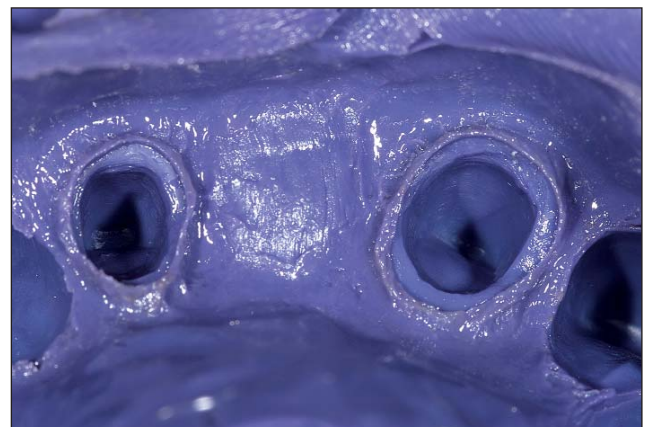
Figure 21: a-b – Soft tissue and conventional impression

is only maintained as a result of the pressure created by the shape of the pontic. Once the bridge is removed the profile starts to collapse and is further distorted by the placement of retraction cord around the abutment teeth. Two impressions need to be taken. The first should be taken with the specially created stent and prior to the use of retraction cord to ensure that the soft tissues are undistorted in the final working model (Figure 21a). The second is a conventional working impression following placement of the retraction cord (Figure 21b). Impregum Penta Soft (3M ESPE) was used with both impressions.

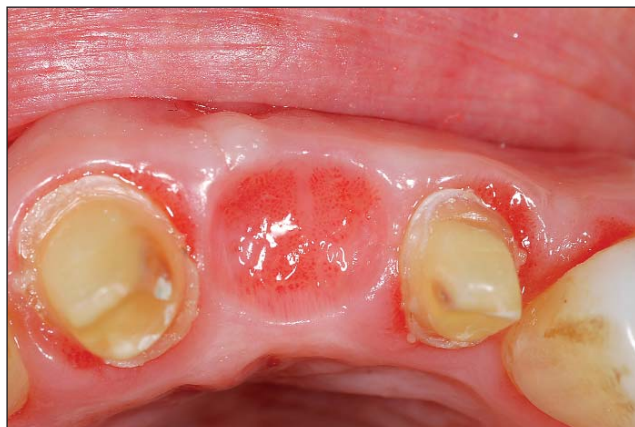
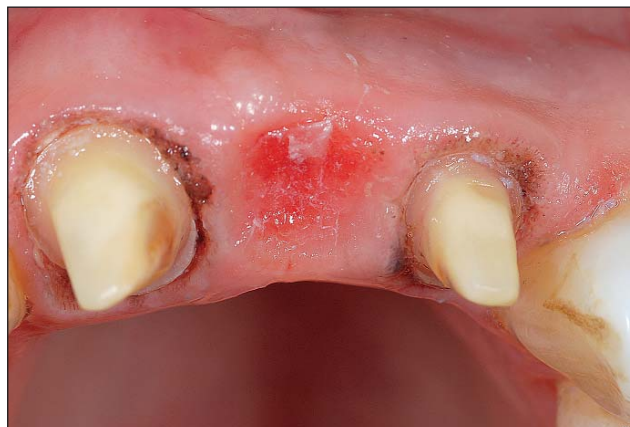
Figure 22: a-b – The tissues pre and post conventional impression

Figures 22a-b clearly show the completely distorted clinical picture of the soft tissues after the final impression was taken and compared to the beautifully created emergence profile. Providing the technician with this altered tissue profile as the sole working model would completely negate the effort taken to produce it in the first place. Careful adherence to the technique, as described, will ensure that the fabricated definitive bridge will faithfully and passively reproduce the necessary contours to maintain the desired final appearance.

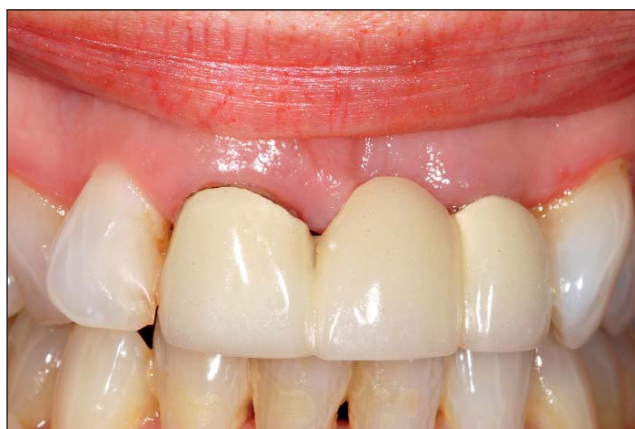
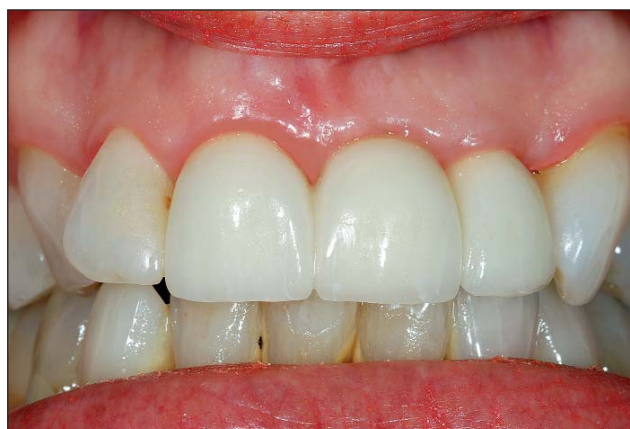
Figure 23: a-b – Recall at 18 weeks – before and after appearance

The final aesthetic result is shown in the before and after views of the case (Figures 23a-b). The appearance is natural and was further enhanced by some tooth whitening during temporisation and the addition of some bonded composite [Venus (Heraeus Kulzer)] to the mesio-incisal aspect of the right lateral incisor in order to optically upright the tooth and further improve the harmony of the aesthetics. The gingival heights are harmonious and blend seamlessly with the natural teeth. The appearance achieved is natural.
